### **Fire safety summary: Fire research conducted for the project on mid-rise wood construction (Report to research consortium for wood and wood-hybrid mid-rise buildings)**

# **REPORT TO RESEARCH CONSORTIUM FOR WOOD AND WOOD-HYBRID MID-RISE BUILDINGS**

CLIENT REPORT: A1-004377.1

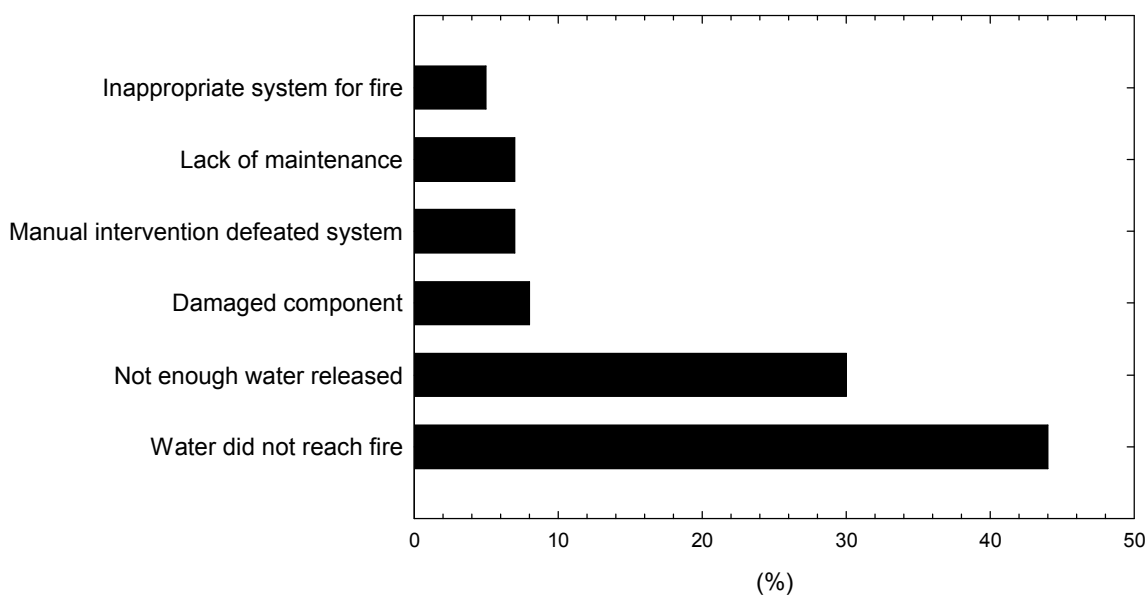
Reference [12] provides results for the primary reasons that the sprinkler system was ineffective when activated by a fire. Table 4, extracted from Reference [12], provides the percentages for each reason automatic sprinklers were ineffective by property use in 2007-2011. The results are also illustrated in Figure 2 based on the 4% of the fires in which the sprinklers operated in all structures but were ineffective.

Sprinkler ineffectiveness in non-confined fires was primarily because the water did not reach the fire (44%) or because not enough water was released (30%). Other reasons included damage to a system component (8%), manual intervention (7%), lack of maintenance (7%) and inappropriate equipment for the type of fire (5%).

**Figure 2. Reason when sprinklers are ineffective 2007-2011 (all sprinklers and all structures).**

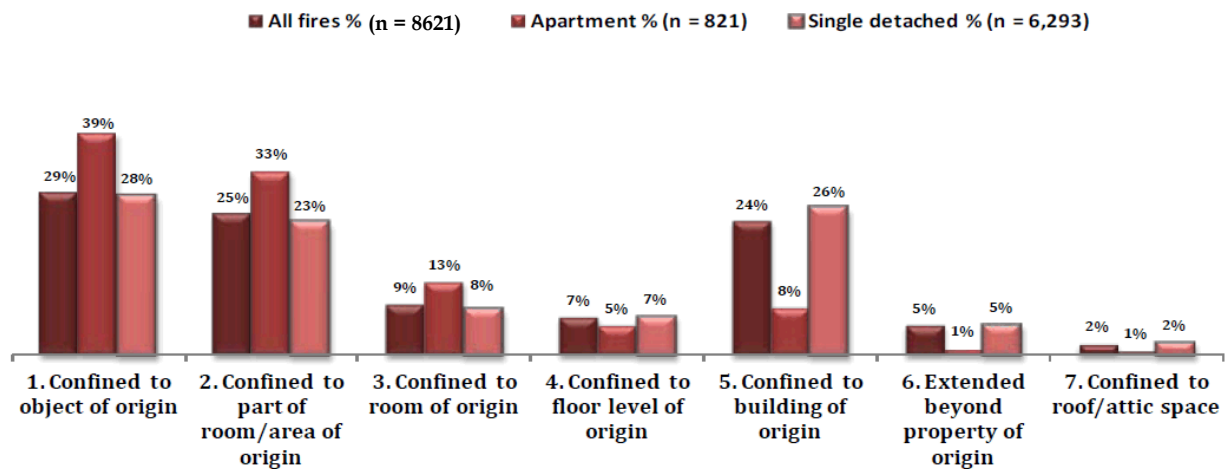
The extent of fire spread for residential buildings was investigated in Reference [17] using the Province of British Columbia's fire statistics for the period between October 2006 and October 2011. The extent of fire spread in residential properties with the fire controlled by the sprinkler system is shown in Figure 3. Figure 4 shows the extent of fire spread in residential properties without sprinkler protection.

Figure 4. Extent of fire spread for buildings without sprinkler protection, by property classification [17].

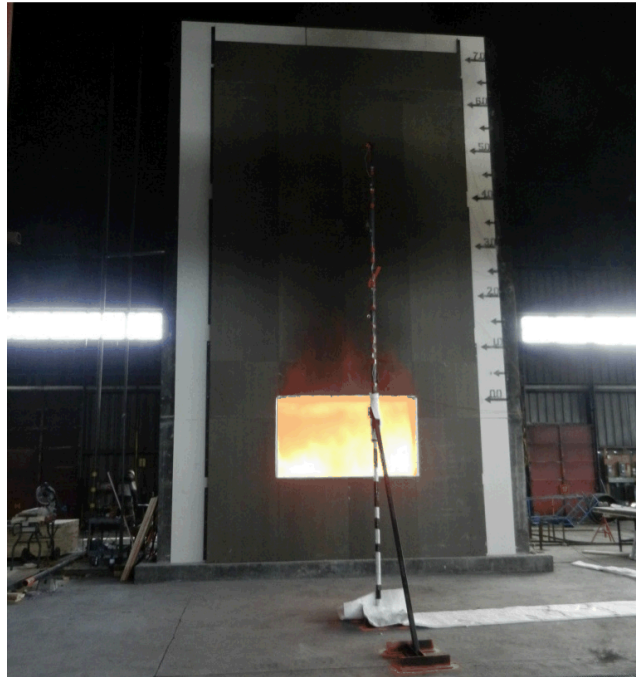
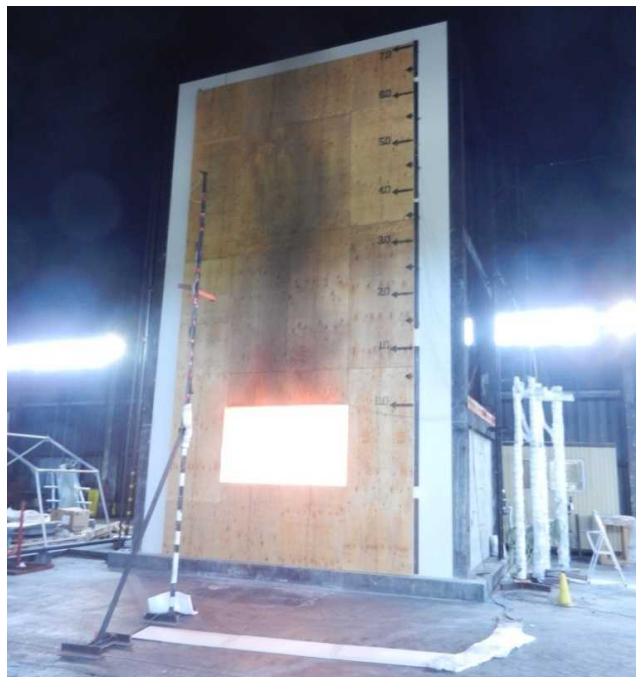
The tests were conducted in accordance with CAN/ULC-S134 [21] in the NRC large scale fire laboratory. Figure 6 shows the exterior wall fire test facility.

**Figure 6. Tests of Exterior Wall Assemblies.**

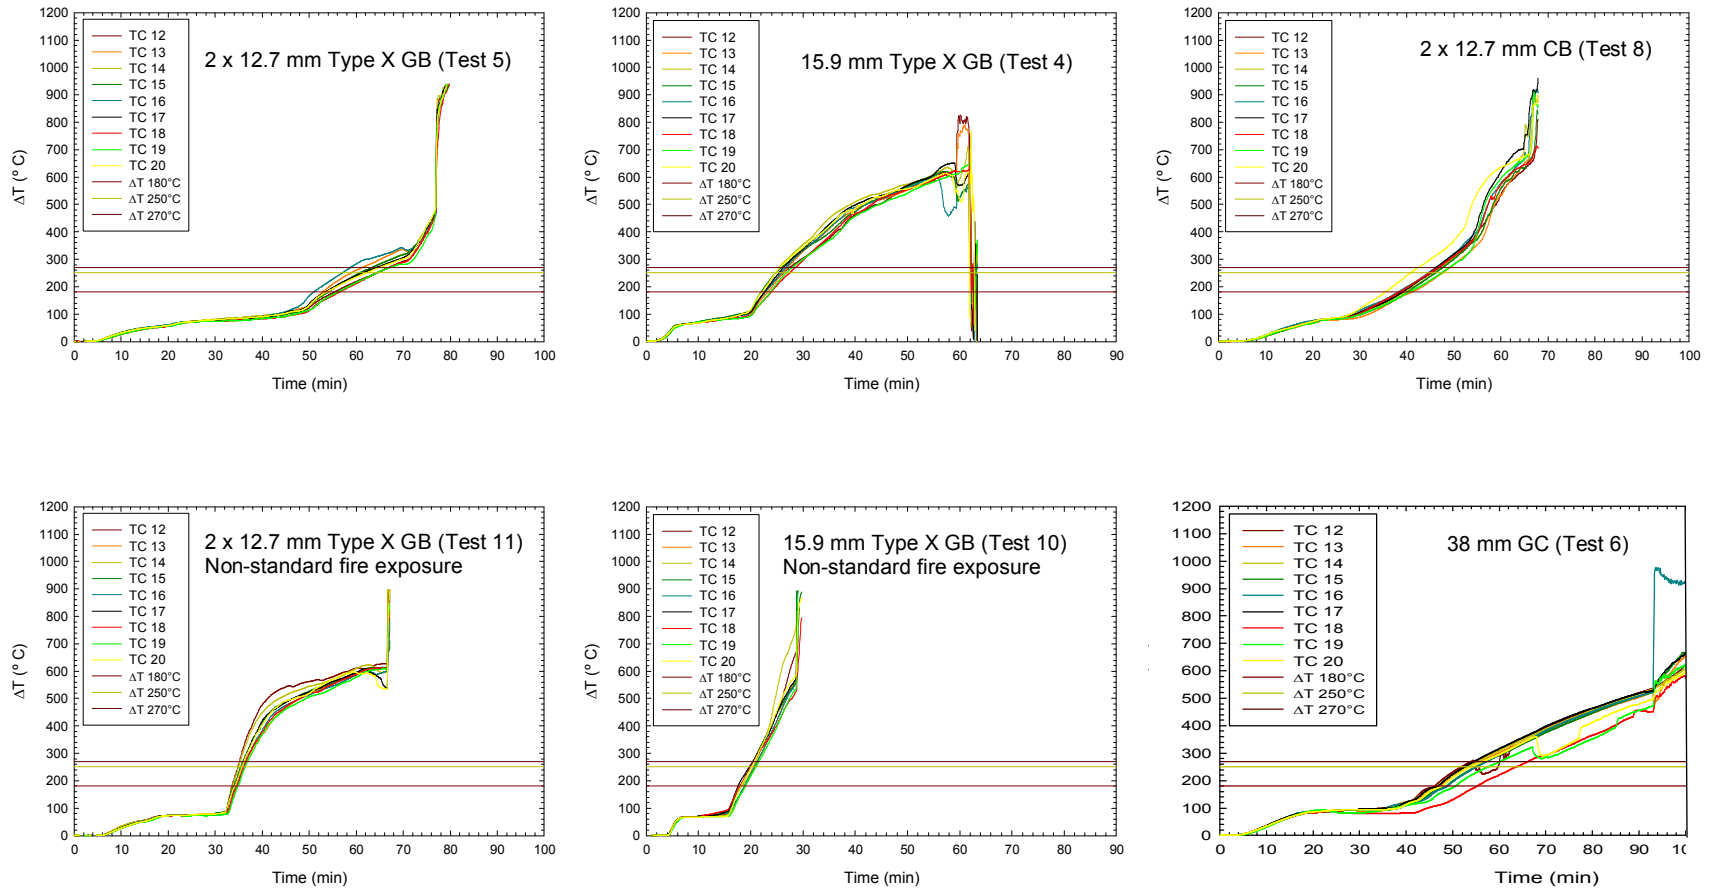
**Figure 9. Temperature rise value profiles at the interface between the encapsulation material and the plywood substrate in intermediate-scale furnace tests (GB: gypsum board; CB: cement board; GC: gypsum-concrete).**

Table 14 shows the results of the intermediate-scale furnace tests conducted to investigate the performance of the encapsulation materials, including nine tests using the standard time-temperature curve and two tests using the non-standard time-temperature curve. The times at which the three sets of criteria were exceeded in each test are provided in the table. These times are based on either the single-point or average temperature rise value at the interface, whichever was exceeded first. Figure 9 shows exemplar temperature rise profiles measured at the interface between the encapsulation material and the plywood substrate.

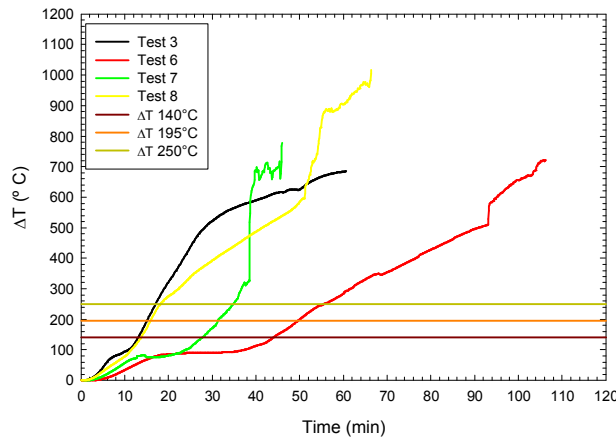
**Figure 11. With standard fire exposure, average temperature rise beneath face layer cement board and gypsum-concrete encapsulation materials.**

The profiles of the average temperature rise value for a single layer of 12.7 mm thick cement board in single or double layer applications (Tests 3 and 8) and the 25 and 38 mm thick gypsum-concrete (Tests 7 and 6, respectively) are shown in Figure 11. These profiles were somewhat similar to those for one layer of gypsum board, with an initial temperature rise followed by a stage during which the water in the cement board or the gypsum-concrete was removed followed by a third period with a more rapid increase in the temperature rise value.

For the single (face) layer of cement board, the rate of the initial increase in the temperature rise value and removal of the water from the sample occurred within a short time (approximately 10 min). This process was longer for the two gypsum-concrete samples, which were 2 and 3 times thicker than the cement board.

The average temperature rise criteria are shown on the plots for the average temperature rise values measured in the intermediate-scale furnace tests Figure 10, Figure 11 and Figure 12. The time at which the average temperature rise criteria were exceeded was in the time period with a rapid increase in the temperature rise value after the calcination/removal of water from the encapsulation material. As a result, the difference in times determined using the three criteria was small.

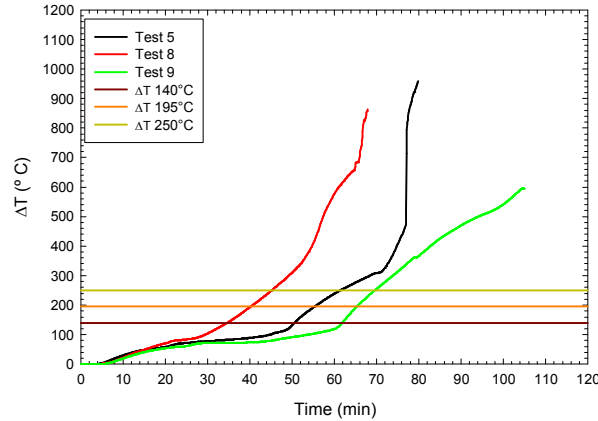
**Figure 12. With standard fire exposure, average temperature rise beneath base layer of two layers encapsulation material.**

The profiles of the average temperature rise values at the interface between the base layer of the encapsulation material and the plywood substrate for the tests with two layers of the board materials are shown in Figure 12. The general trend was the same for the three encapsulation materials with a gradual increase in the temperature rise values starting at 4 – 5 min. This gradual increase continued until calcination of the gypsum board materials (Tests 5 and 9) and the removal of the water from the cement board (Test 8). After calcination/removal of the water from the encapsulation material, the rate of the increase in the temperature rise values accelerated.

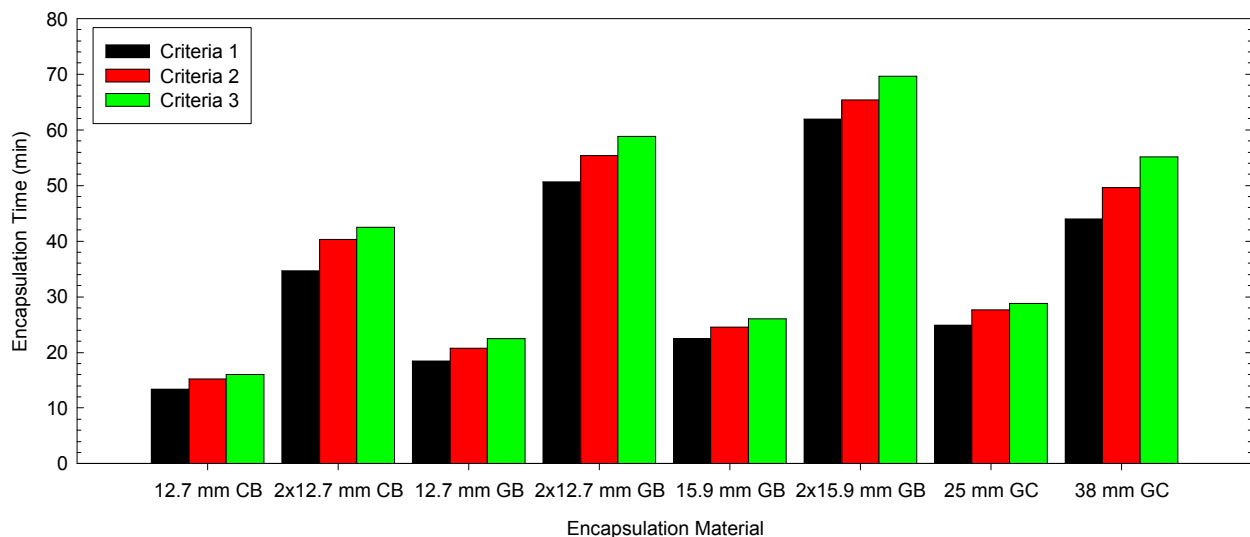
The relative performance of the encapsulation materials under the standard time-temperature exposure is shown in Figure 15. The time difference between Criteria 1 and 3 was < 3 min for the single layer of cement board, 3 - 6 min for the single layer of gypsum board, 8 min for the 2 layers of board products, and 11 min for the 38 mm thick gypsum-concrete.

**Figure 15. Encapsulation times in intermediate-scale tests with standard fire exposure.**

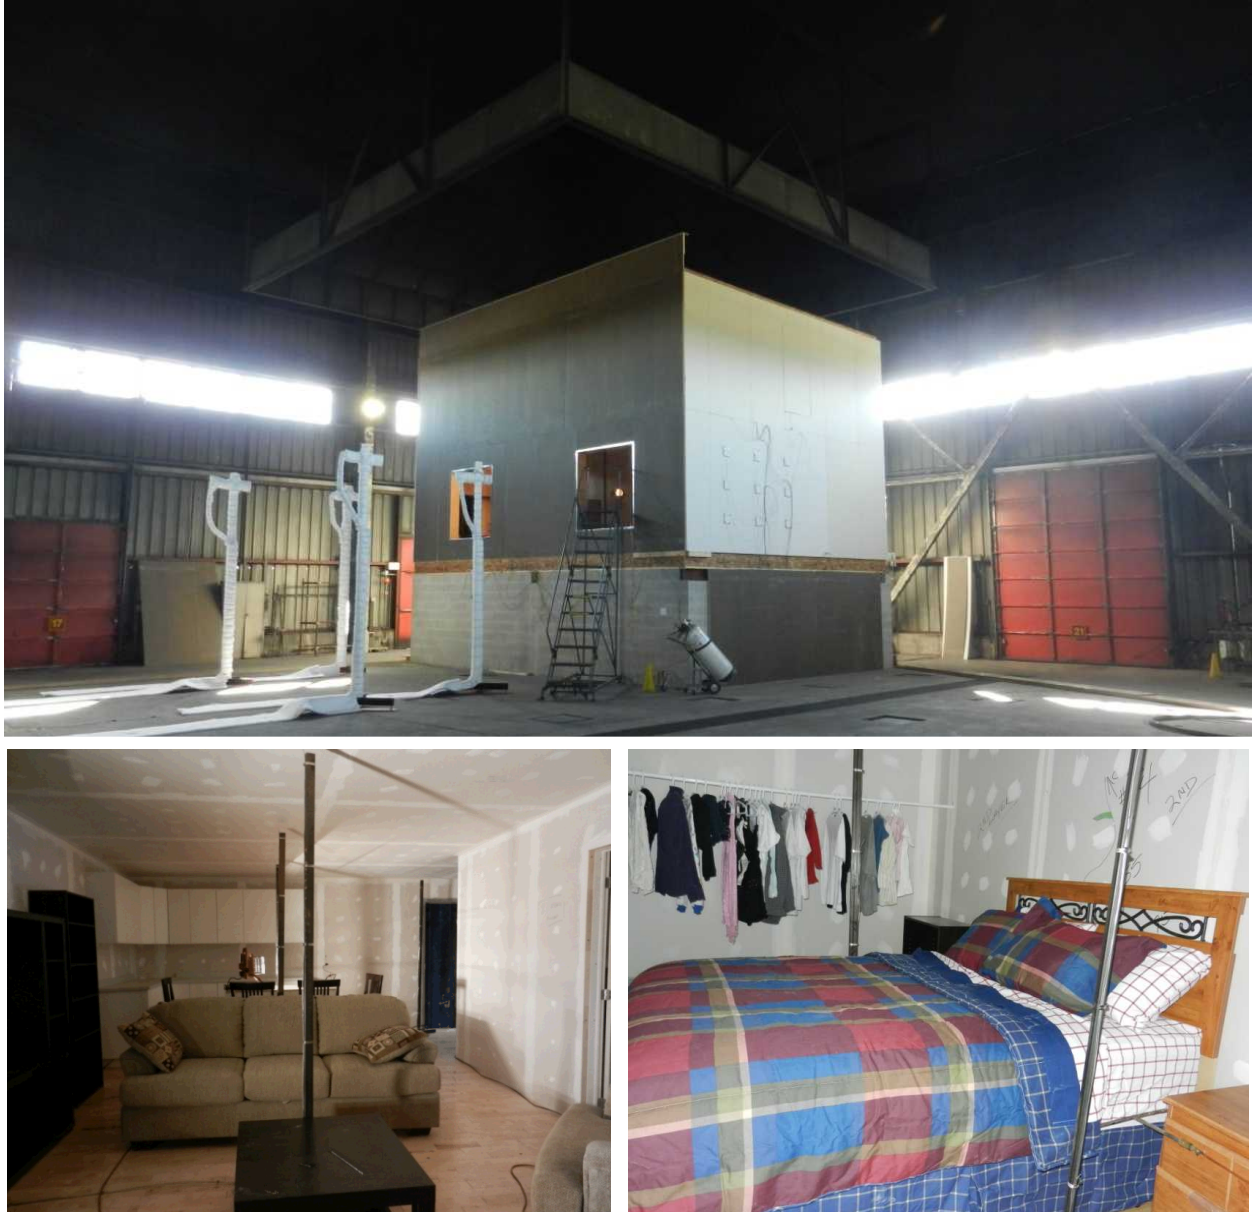
**Figure 28. One of the large-scale apartment test setups.**

Figure 27 shows an elevation view and plan view of the test setup. Figure 28 shows photographs for one of the test setups. A detailed description of the structural assemblies and the test arrangement is provided in a series of reports [37, 38, 39, 40].

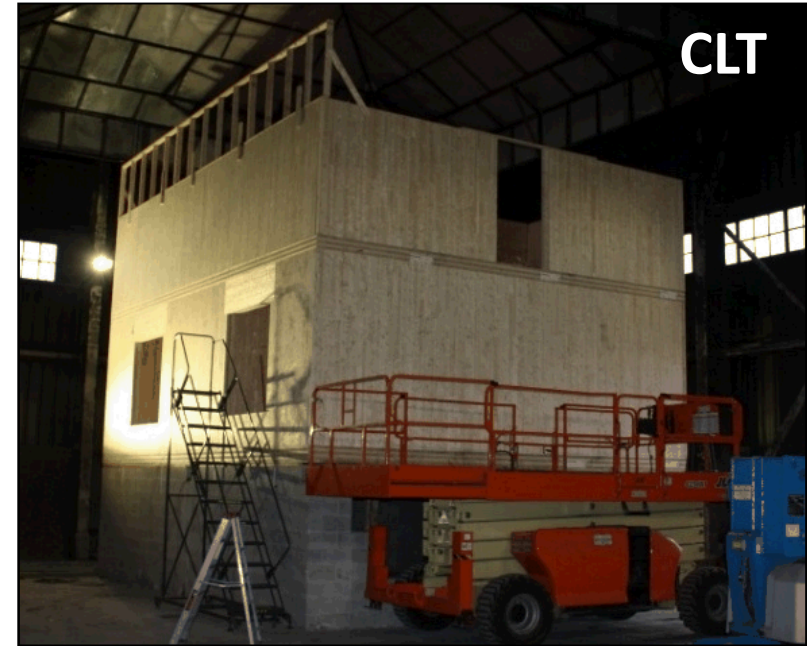
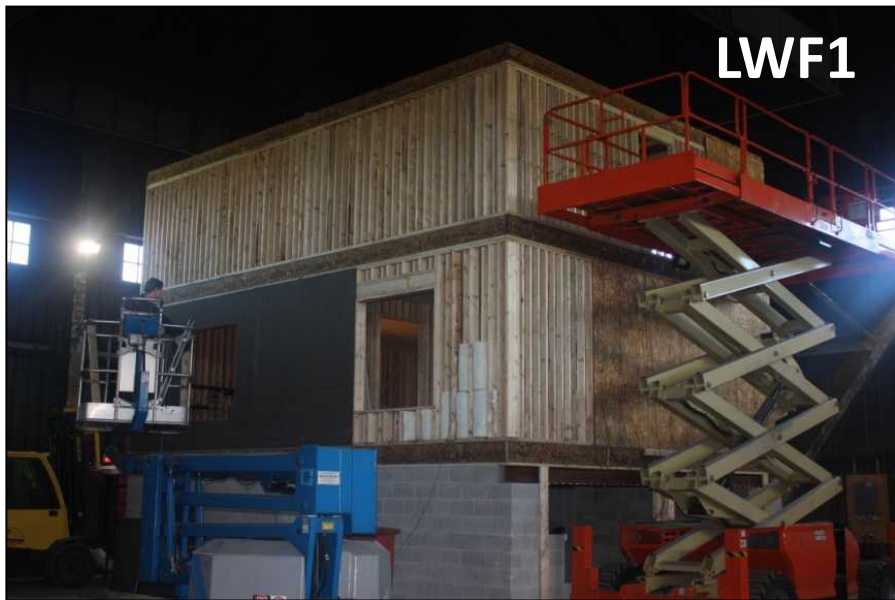
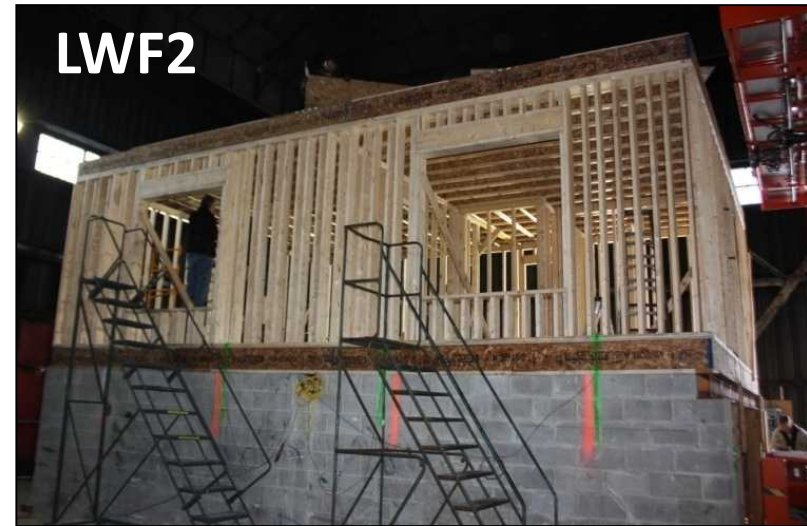
Figure 29. Large-scale apartment test structures under construction.

The middle storey was constructed to simulate a one-bedroom apartment unit with a separate living room kitchen area. The fire was originated in the bedroom of the apartment unit on this middle storey. Table 20 to Table 23 show details of the wall, ceiling and floor assemblies used in the full-scale test setup. Figure 29 shows the test structures under construction.

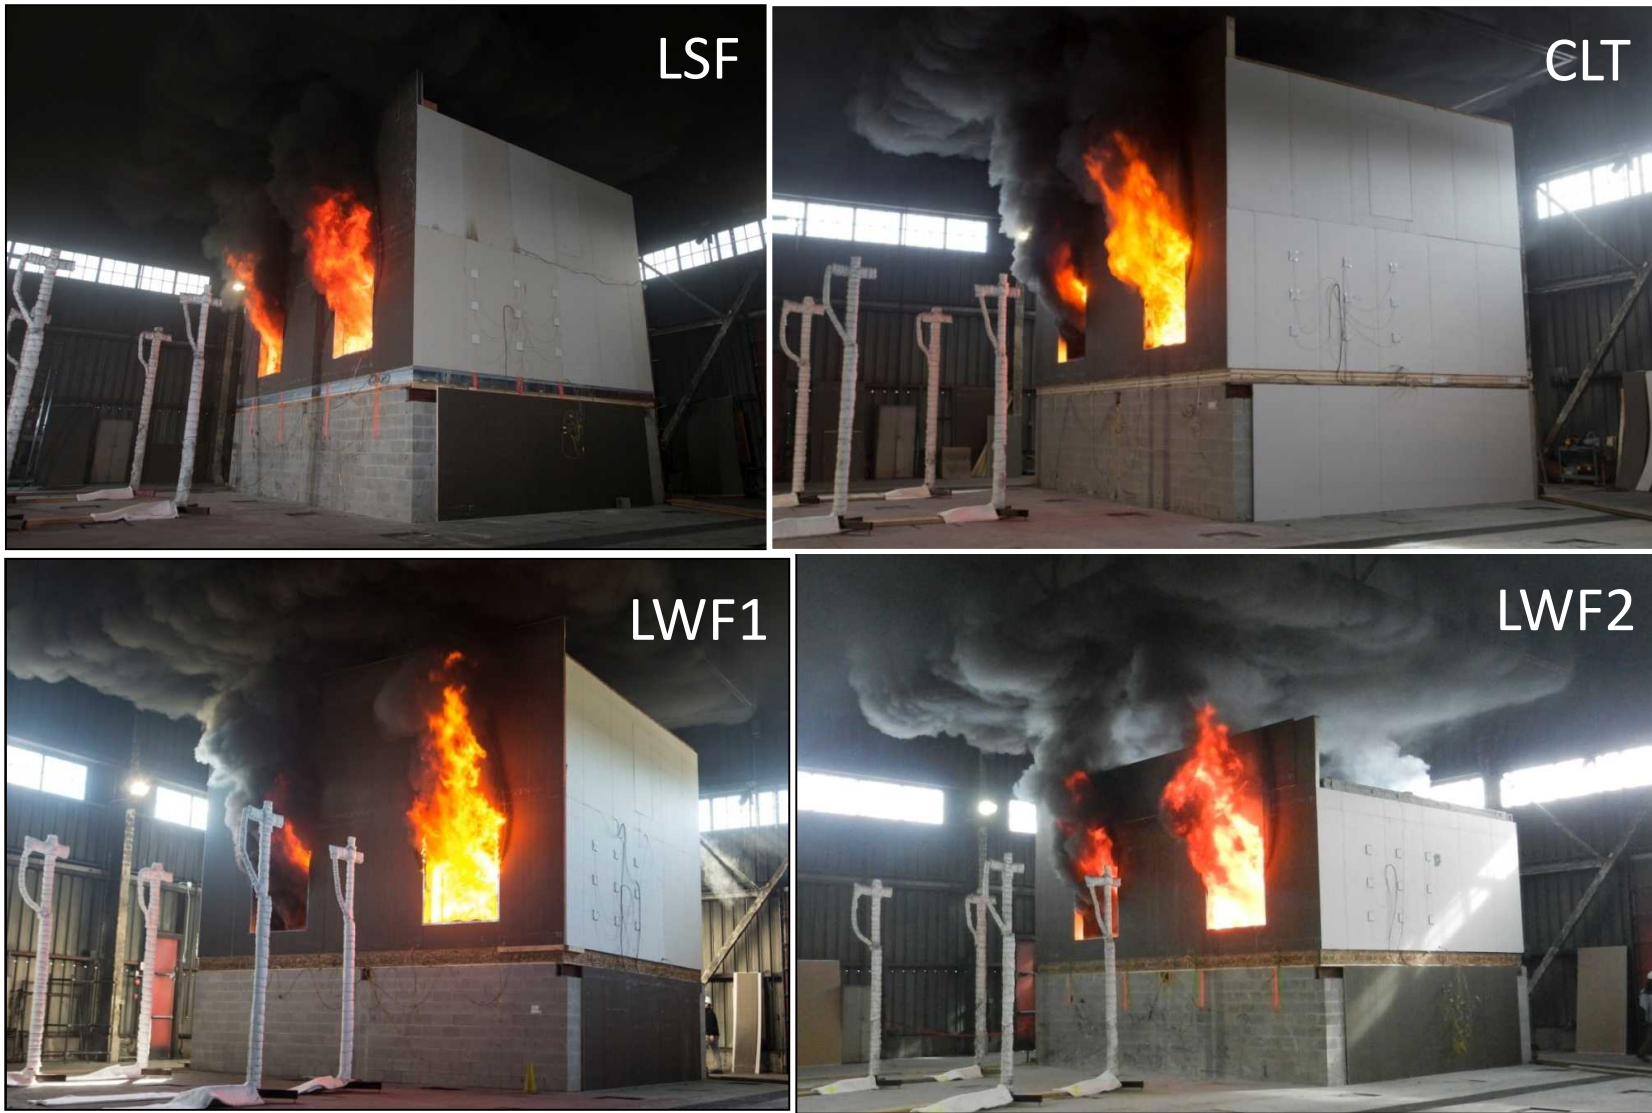
Figure 31. Flashover in both the bedroom and living room areas during large-scale apartment fire tests.

The furniture and contents as well as the hardwood flooring, the kitchen cabinets and counter tops in the fully furnished apartment produced high-intensity fast growing fires with similar initial fire development in all experiments. A smoke alarm was activated in less than 20 s. Flashover occurred in the bedroom at approximately 3 min and the door between the bedroom and the living room was fully breached at 5 min or earlier. Then the fire quickly developed in the living room area and subsequently progressed to the kitchen and entrance area. Localized flashover occurred in the living room/kitchen spaces – typically around 6 min in the living room area, and subsequently progressed to the kitchen area by 10 min and to the entry area by 19 min. Photographs taken after flashover in both the bedroom and living room area are shown in Figure 31.

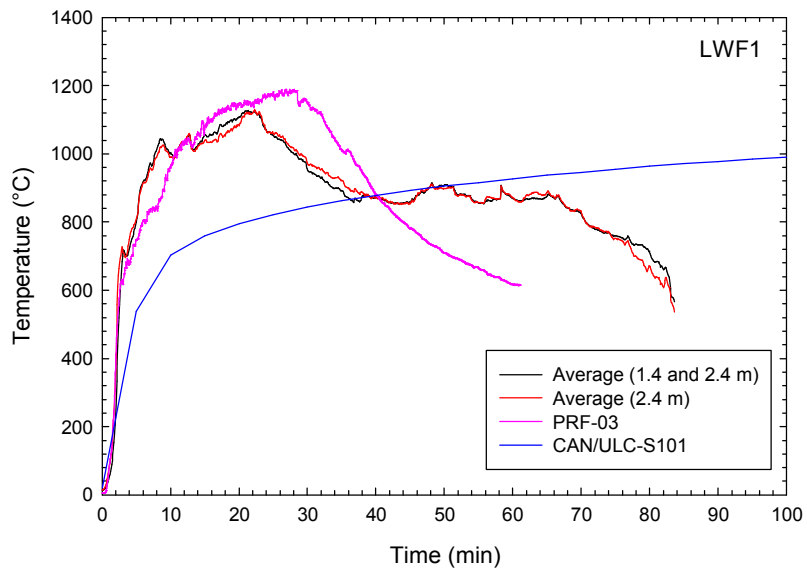
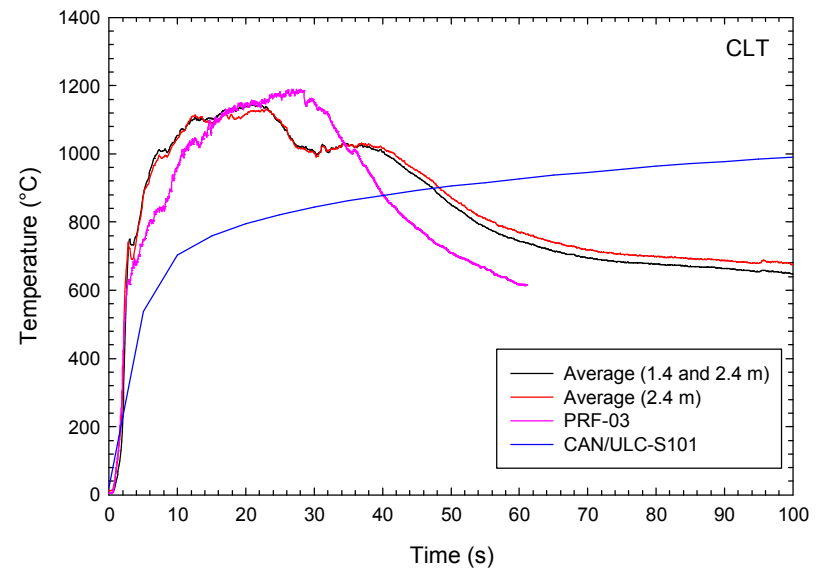
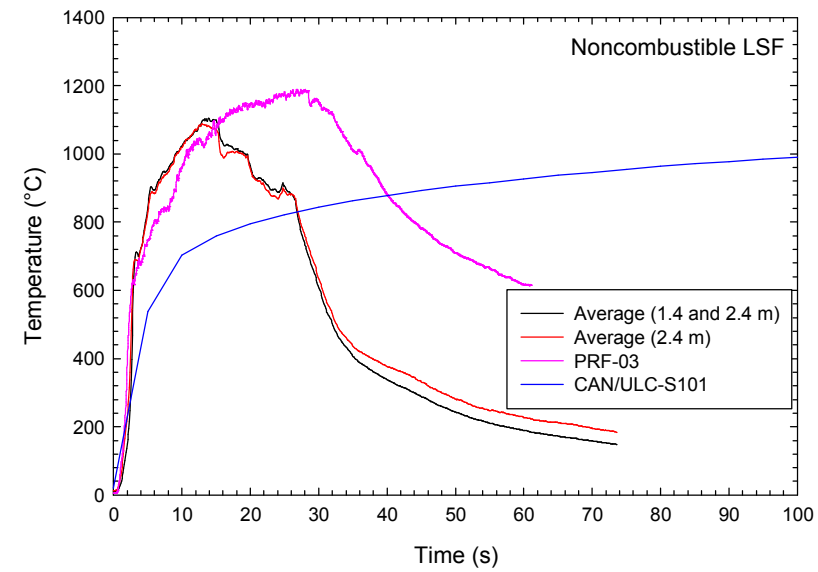
Figure 32. Average temperatures in bedroom.

Figure 32 shows the average temperatures in the bedroom based on the measurements using four thermocouple trees located at the center of the four room quadrants: a) the average near

The temperature profile from the previous standalone bedroom test (PRF-03) [45] is also shown in Figure 32. The furniture and contents used in Test PRF-03 were the same as that used in the apartment. However, there were some variations in the average temperature profiles.

Also shown in Figure 32 and Figure 33 is the standard time-temperature curve used in standard fire-resistance tests [20]. The peak temperatures in the bedroom and the living area were much higher than the standard time-temperature curve used in fire-resistance tests. For a period in each test, the combustion of the room contents produced more severe fires in the apartment than the standard fire used in fire-resistance tests. As a result, the fire involving the room contents produced a more severe exposure to the room boundaries and challenged the structure more aggressively than in a standard fire-resistance test during this period. However, the duration with the higher fire intensity caused by the room contents was different from test to test depending on the ventilation conditions.

During the initial 35 min, the combustion of the room contents produced much higher temperatures in the bedroom and living room area than the standard time-temperature curve used in fire-resistance tests as shown in Figure 32. As a result, the fire involving the room contents produced a more severe exposure to the room boundaries and challenged the wood structure more aggressively than in a standard fire-resistance test during that period. The kitchen and the entryway area reached peak temperatures at close to 35 min, much later than the living room area. After 35 min, the wood structural elements in the ceiling assembly began to contribute to the fire, although the fire involving the room contents was in the decay phase.

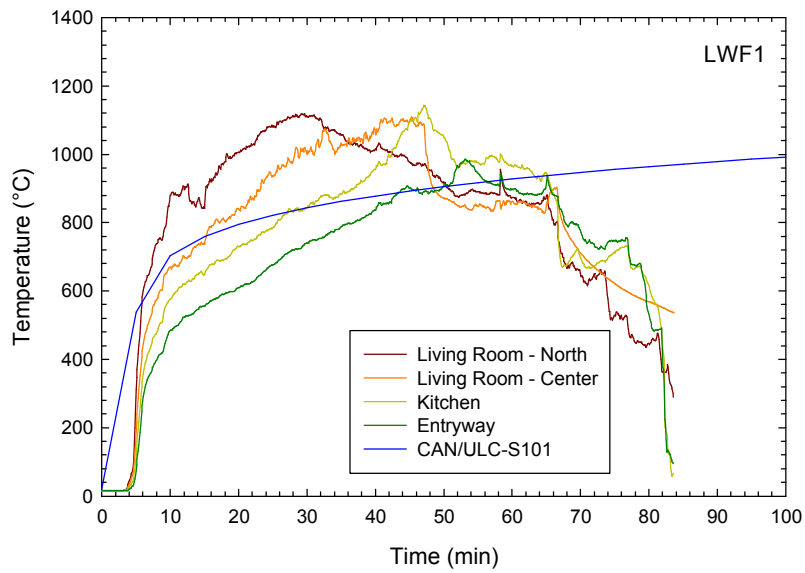
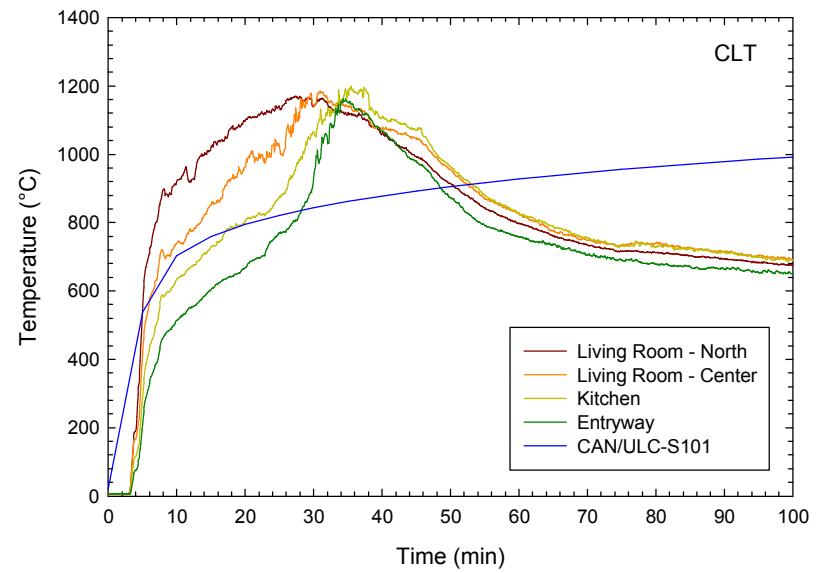
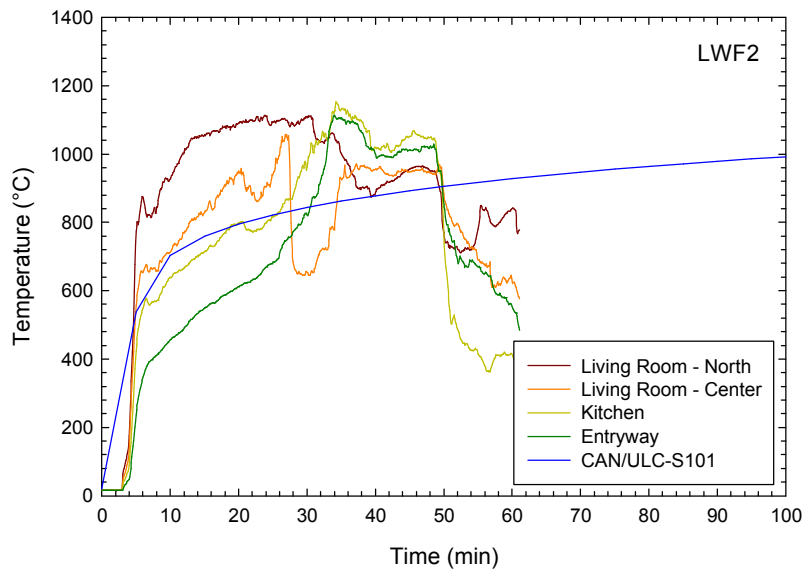
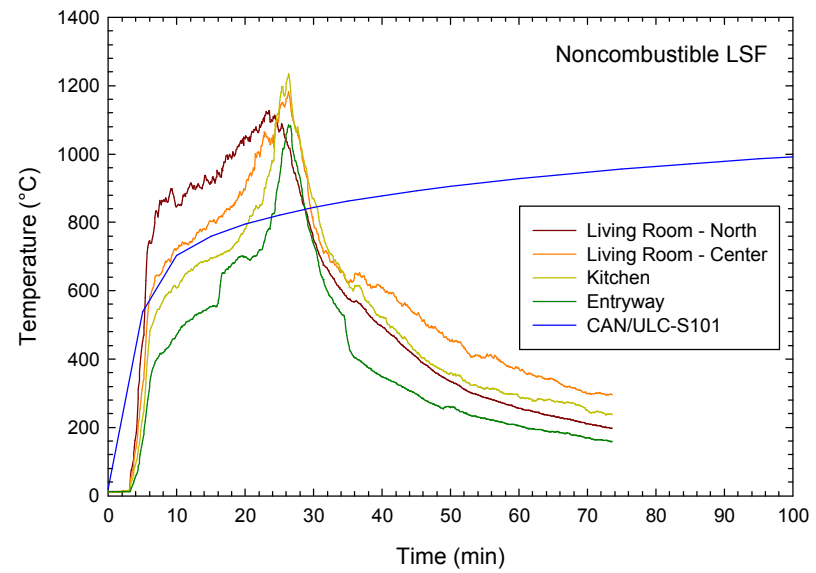
**Figure 33. Average temperatures in living room, kitchen and entryway (1.4 and 2.4 m heights).**

In the living room, kitchen and entryway areas, the temperatures were also uniform with height in the upper portion of the space (the average temperature at the 2.4 m height was similar to the average at the 1.4 and 2.4 m heights). However, the fire in the living room, kitchen and entryway did not develop uniformly throughout the entire area. This is illustrated in Figure 33, by the plots of the average upper layer temperature (1.4 and 2.4 m heights) in each area. The fire developed faster in the living room area than in the kitchen and entry area. Flashover occurred at approximately 6 min in the living room area; progressed to the kitchen area by 10 min; and then to the entry area by 19 min. Peak temperatures of above 1100°C were reached in the living room area by 25 min in all tests, with the peak temperatures reached later in the kitchen and entryway.

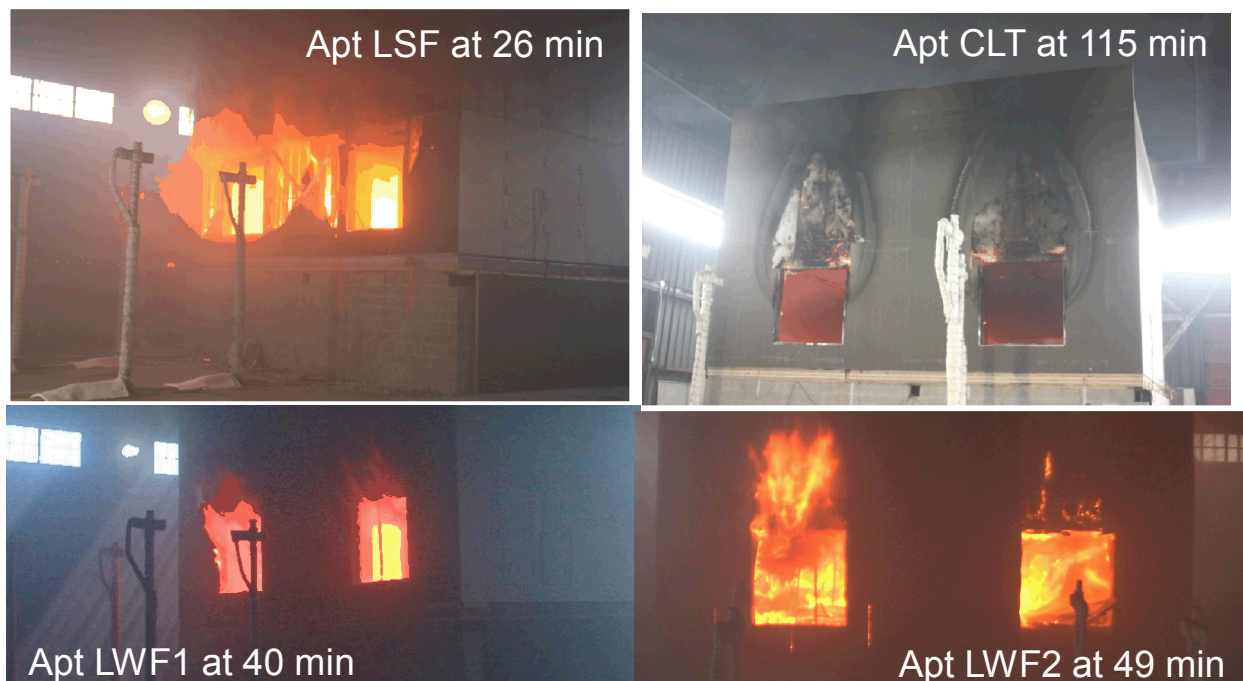
**Figure 34. Ventilation conditions through the exterior openings during the large-scale apartment fire tests.**

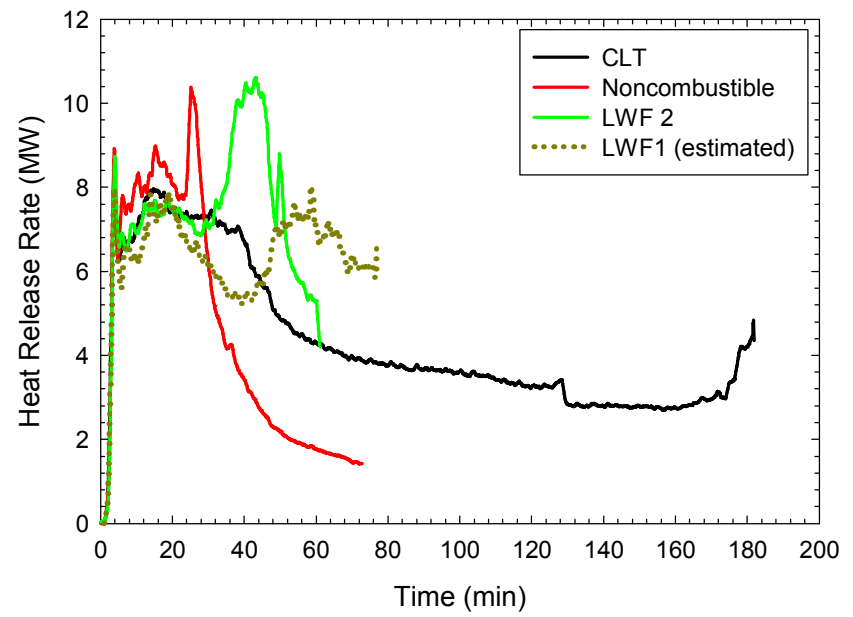
Figure 35. Heat release rate.

Table 24 shows the peak values for the heat release rate and heat flux in each test. Figure 35 to Figure 38 show the profiles measured during the tests.

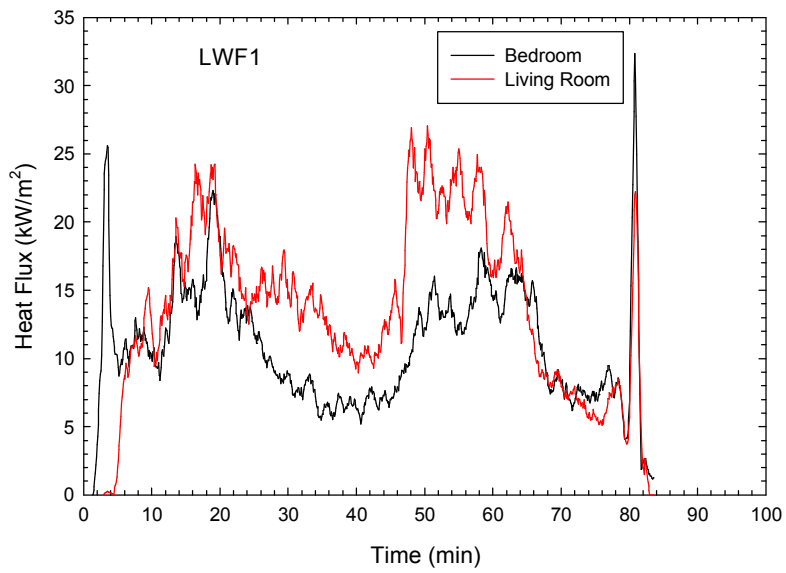
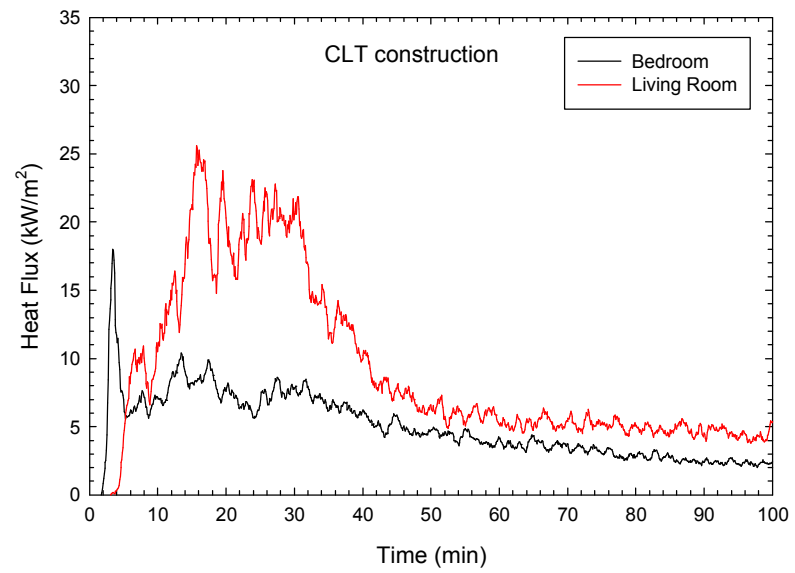
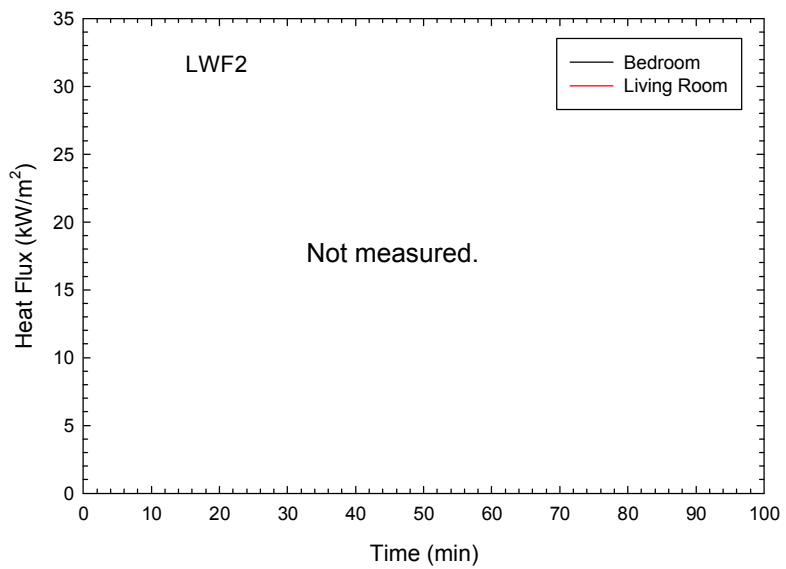
**Figure 36. Heat flux from opening to façade.**

In the Apt LWF1 and Apt LWF2, the relatively steady heat fluxes measured for the living room opening are consistent with the progression of the fire from the living room to the kitchen and the eventual exposure and burning of the joists and subfloor. The peak heat flux was much higher in the Apt LSF test (33 kW/m<sup>2</sup> at the 2.4 m distance) than in the three apartment tests with wood structural elements (21-25 kW/m<sup>2</sup> at the 2.4 m distance). There was another increase in the measured heat flux, corresponding to the burning of the wood elements in the ceiling assembly in Apt LWF1 and Apt LWF2 or the second growth of the fire in Apt LSF due to increased ventilation.

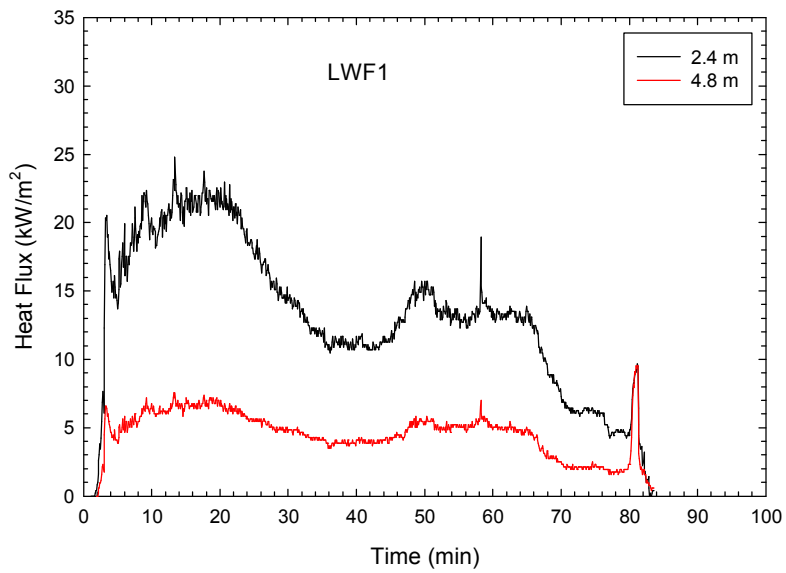
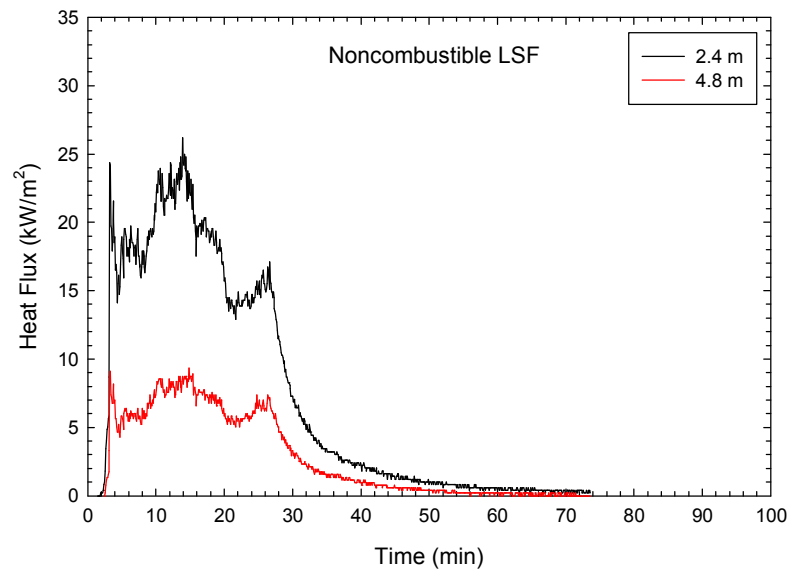
**Figure 37. Heat flux from bedroom opening.**

heat flux values are comparable between the tests (23-28 kW/m<sup>2</sup> at the 2.4 m distance and 7-10 kW/m<sup>2</sup> at the 4.8 m distance) with Apt LWF2 at the high end and Apt LWF1 at the low end. After a period of decline, there was an increase again in the measured heat flux, corresponding to the burning of the wood elements in the ceiling assembly in Apt LWF1 and Apt LWF2 or the second growth of the fire in Apt LSF due to increased ventilation.

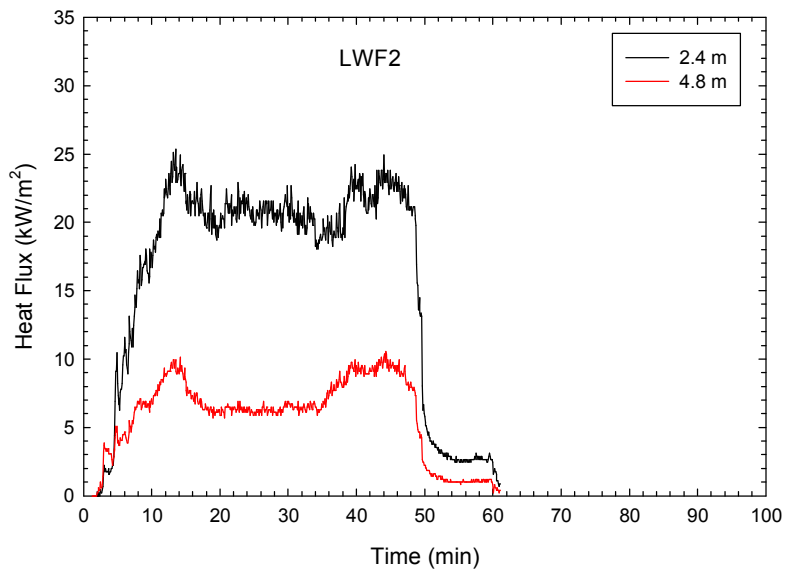
**Figure 38. Heat flux from living room opening.**

At the target locations in front of the living room opening, as shown in Figure 38, there was an initial heat flux measured as the flames projected from the bedroom opening. As the fire developed into the living room area and subsequently progressed to the kitchen and entrance area, there was a rapid increase in the heat flux with the flashover of the living room/kitchen area.

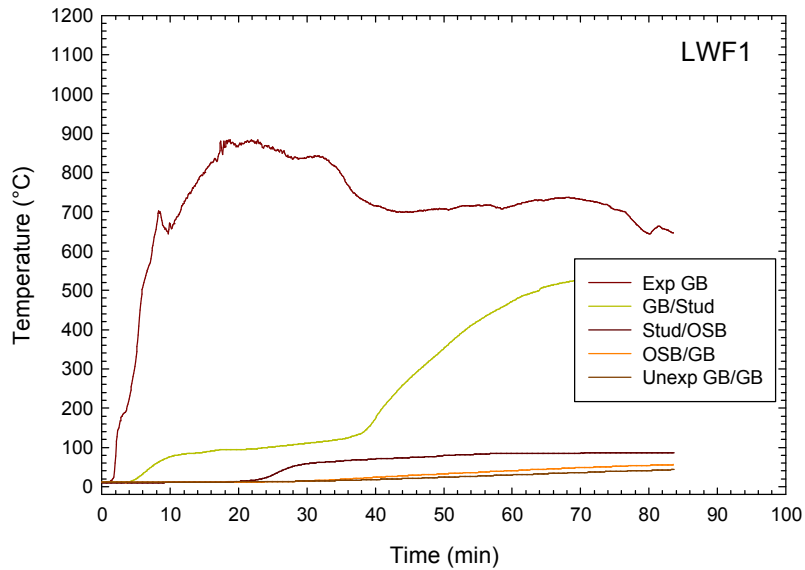
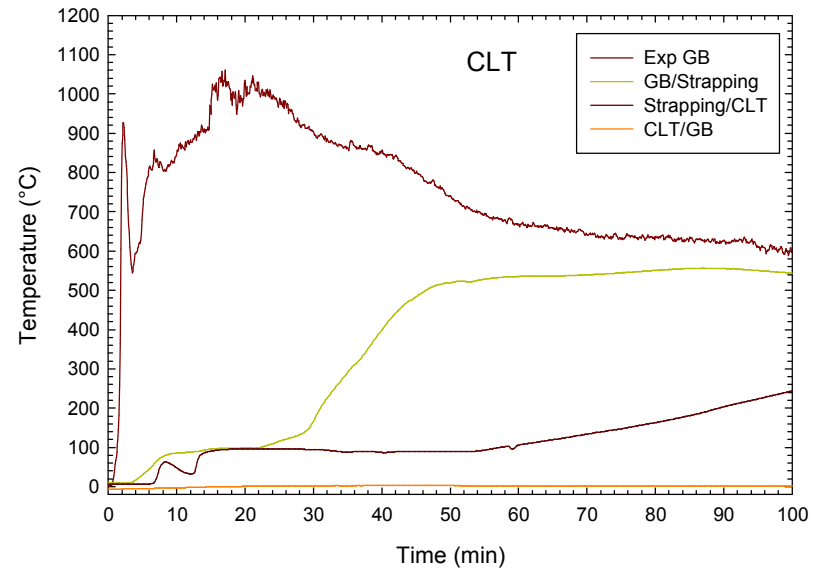
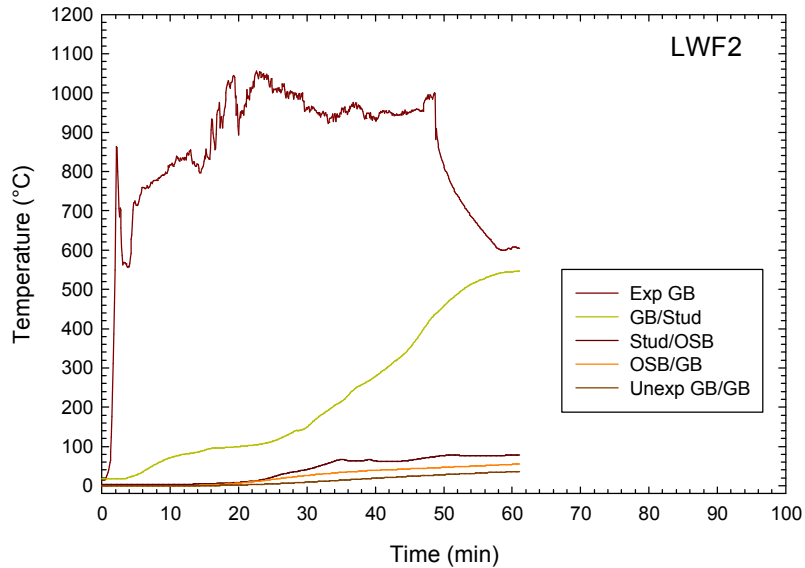
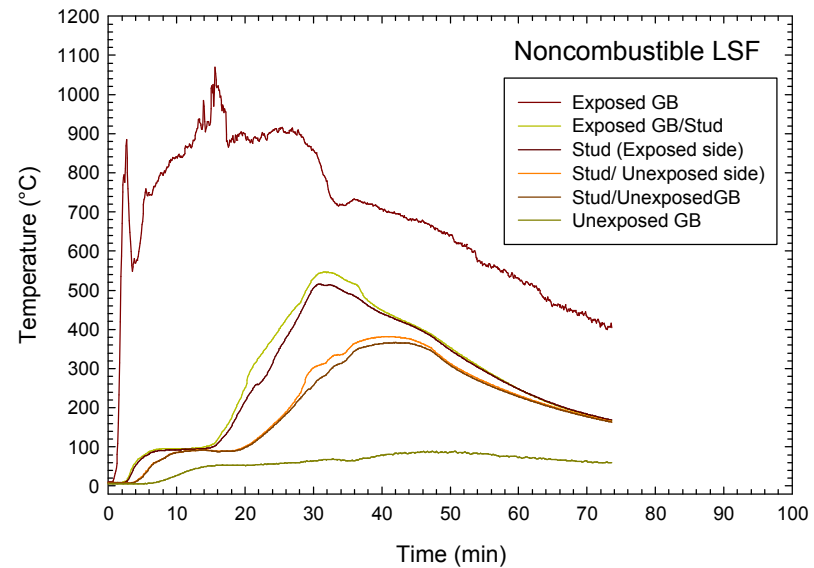
**Figure 39. Temperatures at various interfaces in the bedroom WA2 wall assemblies (mid length, 1.2 m height).**

Temperatures were also measured at each interface across the WA2 wall from its exposed to unexposed face at the centre in the bedroom. Figure 39 shows temperature profiles measured at various interfaces in the bedroom WA2 wall assembly at the mid-length and 1.2 m height.

The temperature rise values at the interface between the base layer gypsum board and the stud reached the 250°C and 270°C limits at 45 min in Apt LWF1 and at 38 min in Apt LWF2. Thus the studs would begin to char after this time due to direct heat transfer from the gypsum board to the studs, but the temperatures were below 500°C, which indicates no flaming combustion at the studs. Low temperatures were measured at the interfaces on the unexposed side of the WA2 wall, including the stud interface with the OSB shear layer (less than 90°C), the interface between the OSB and gypsum board base layer (less than 60°C) and the interface between the two layers of gypsum board (less than 50°C). The temperatures measured using the nine thermocouples covered with pads on the unexposed side of the WA2 wall were 40 – 60°C at the end of the test.

These results suggest that the fire did not affect the wood structural elements in the WA2 wall until after at least 45 min in Apt LWF1 and 38 min in Apt LWF2; the impact of the fire on the wood elements was limited on the gypsum board-stud interface with the direct heat transfer through the gypsum board into the studs. The WA2 wall assembly did not in any way contribute to the growth and spread of the fire.
