### **Fire safety summary: Fire research conducted for the project on mid-rise wood construction (Report to research consortium for wood and wood-hybrid mid-rise buildings)**

# **REPORT TO RESEARCH CONSORTIUM FOR WOOD AND WOOD-HYBRID MID-RISE BUILDINGS**

CLIENT REPORT: A1-004377.1

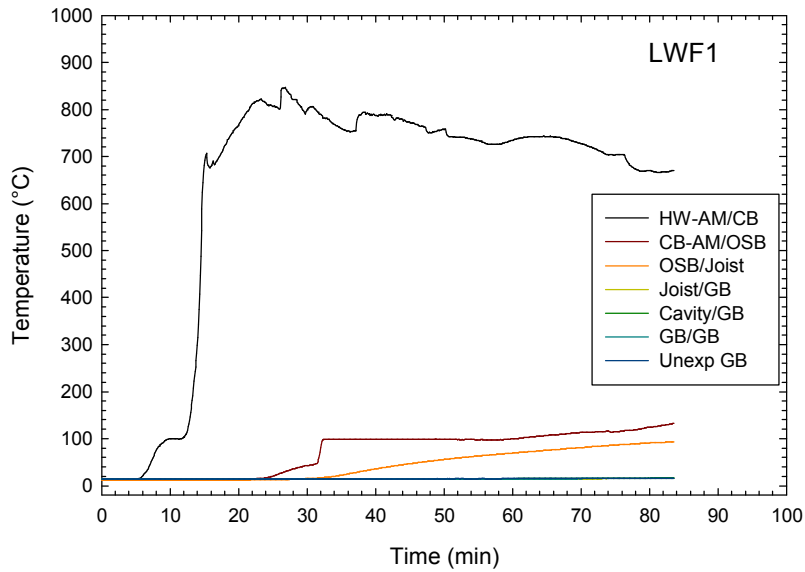
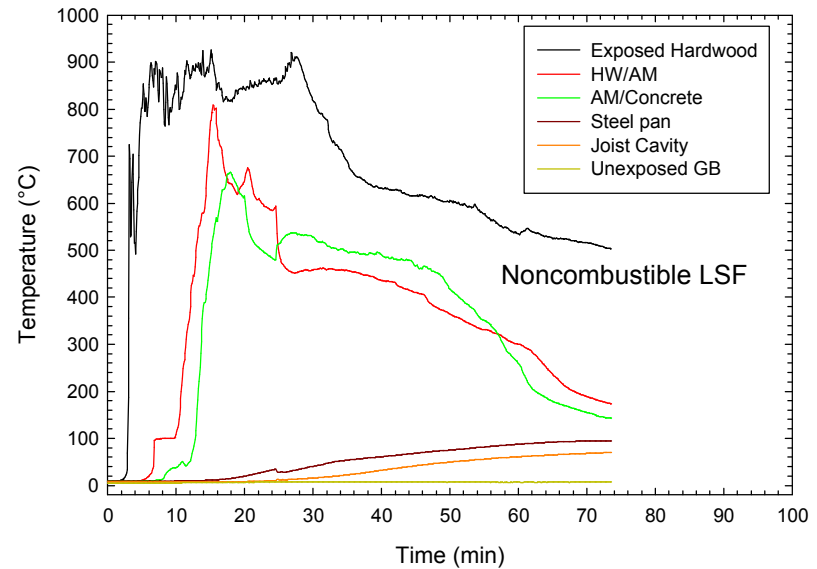
**Figure 40. Temperatures at various interfaces in the bedroom floor assemblies.**

In Apt LSF, the temperatures were below 100°C underneath the concrete subfloor and below 80°C in the cavities of the floor assembly during the test.

Figure 40 shows some exemplar temperature profiles measured at various interfaces in the bedroom floor assemblies.

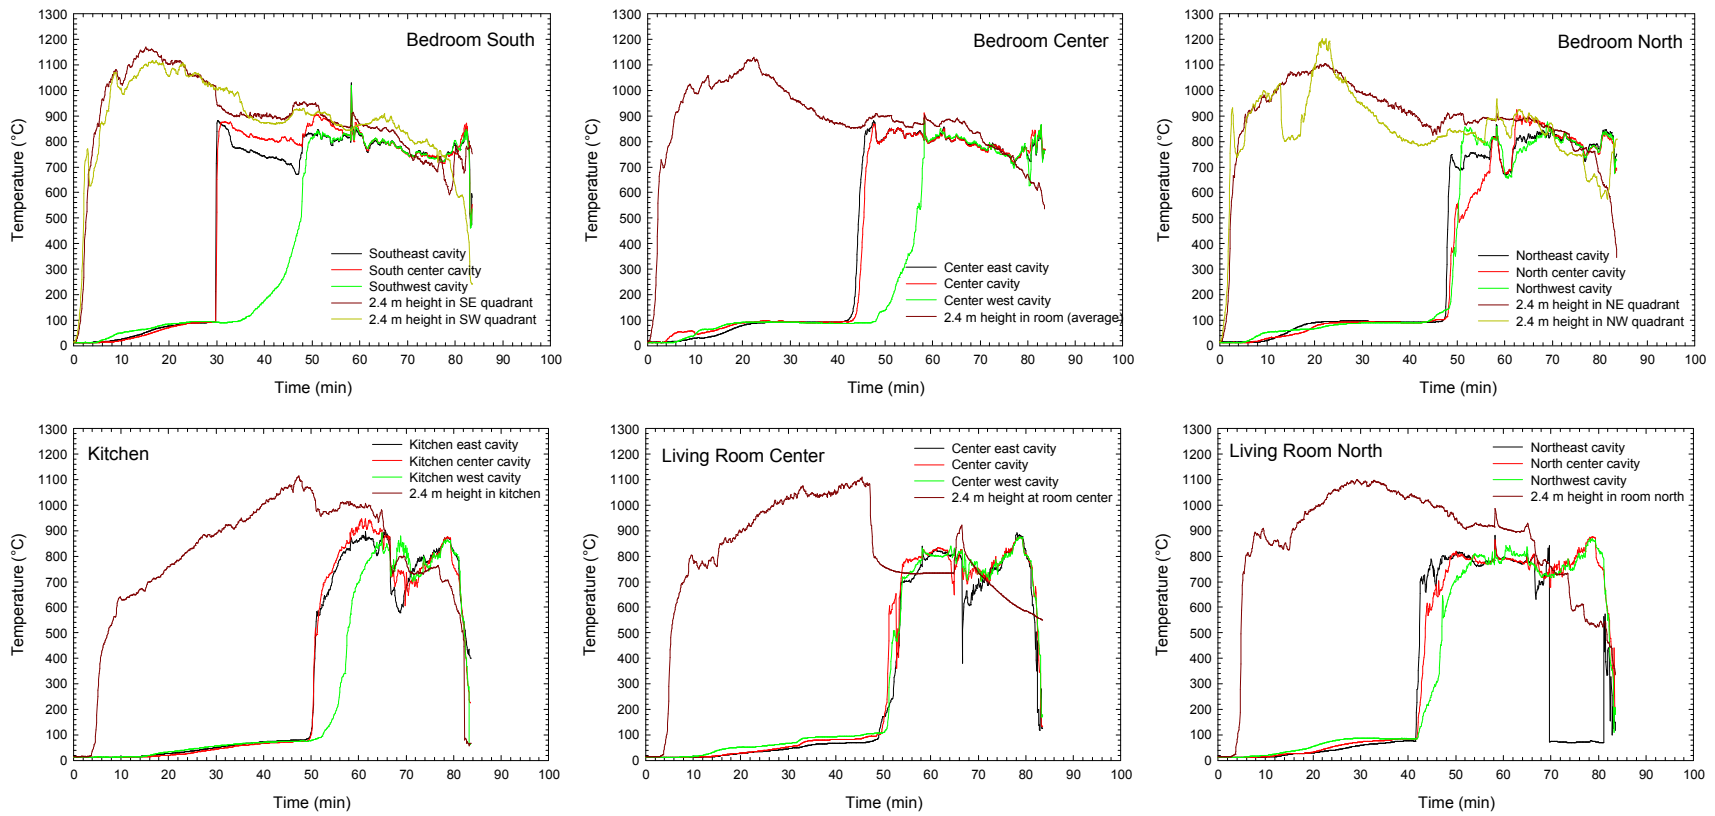
Figure 42. Temperatures in ceiling cavities versus temperatures in fire compartment at the 2.4 m height during Test Apt LWF1.

Figure 41 to Figure 45 show the temperature profiles measured in the cavities and at various interfaces of the ceiling assemblies, along with the temperatures in the fire compartment at the ceiling height (2.4 m height) during the large-scale apartment tests.

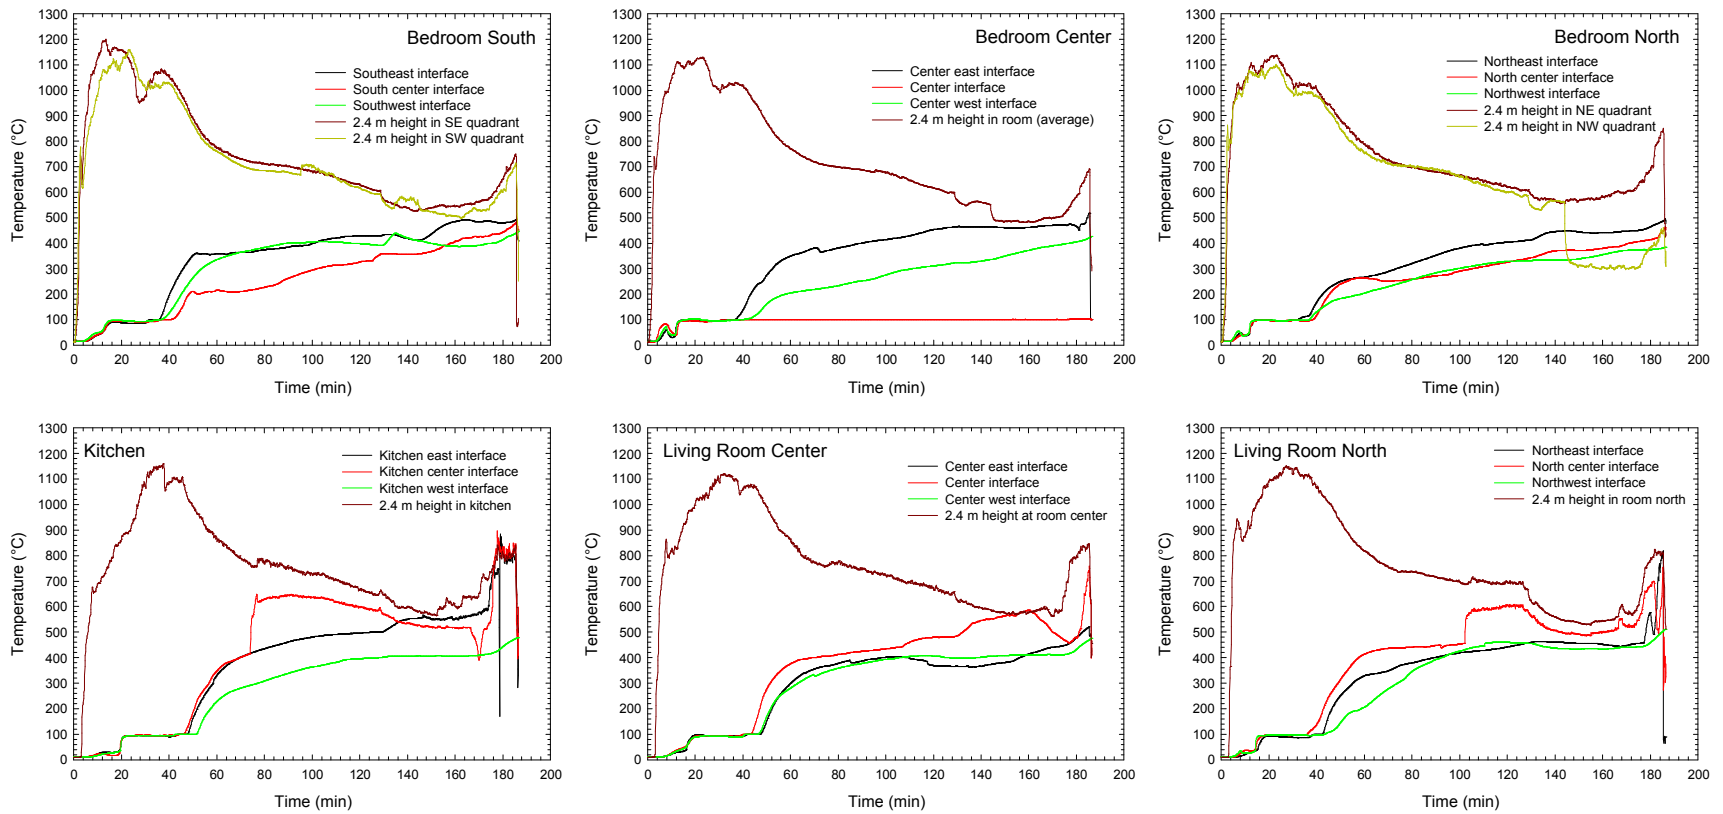
**Figure 44. Temperatures at the interface between gypsum board and CLT in the ceiling assemblies versus temperatures in fire compartment at the 2.4 m height during Test Apt CLT.**

Peak temperatures above 600°C were measured at the gypsum board-CLT interface along the North- South centerline in the living room, indicating flaming combustion on the CLT ceiling panels. After 170 min, visible flames were observed on the CLT panels along the centerline of the living room, which soon spread to the entire ceiling. The test was terminated at 185 min with the fire extinguished by the local fire department using water hose streams.

The temperature rise values measured on the unexposed side of the CLT panels and at various interfaces on the unexposed side were less than 10°C, indicating minimal heat transfer through the CLT ceiling panels. The maximum temperature rise value in the space on the third storey was 15°C. Overall, the results suggest that heat losses to the CLT in the ceiling assembly improved the performance of the gypsum board. Further investigations are required to quantify the effect of the thickness of the CLT on the encapsulation time, the temperatures at the interface between the encapsulation material and the CLT, and the fall-off of the encapsulation material.

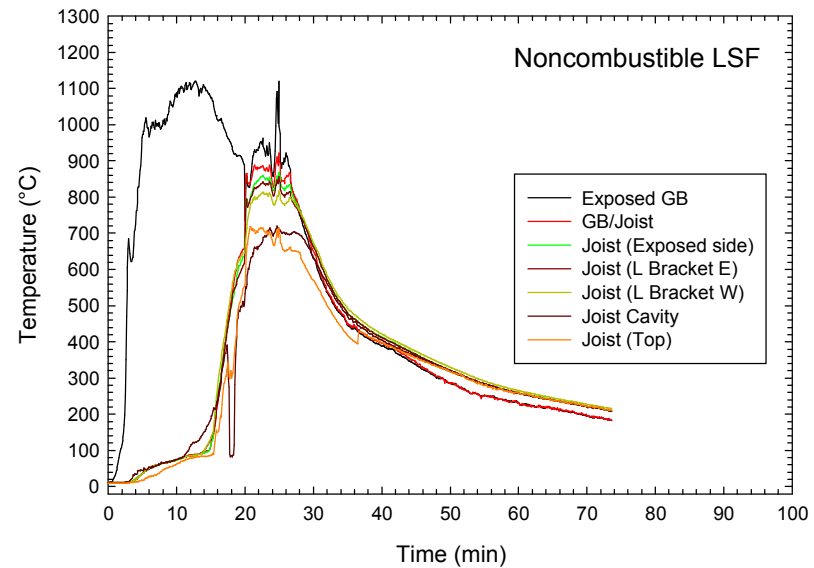
**Figure 45. Temperatures at various interfaces at the centre in the bedroom ceiling assemblies.**
